ENVIRONMENTAL MONITORING PROGRAM TO EXPAND

PRINCE ALBERT ENVIRONMENTAL MONITORING

Important Environmental Information for Prince Albert Residents

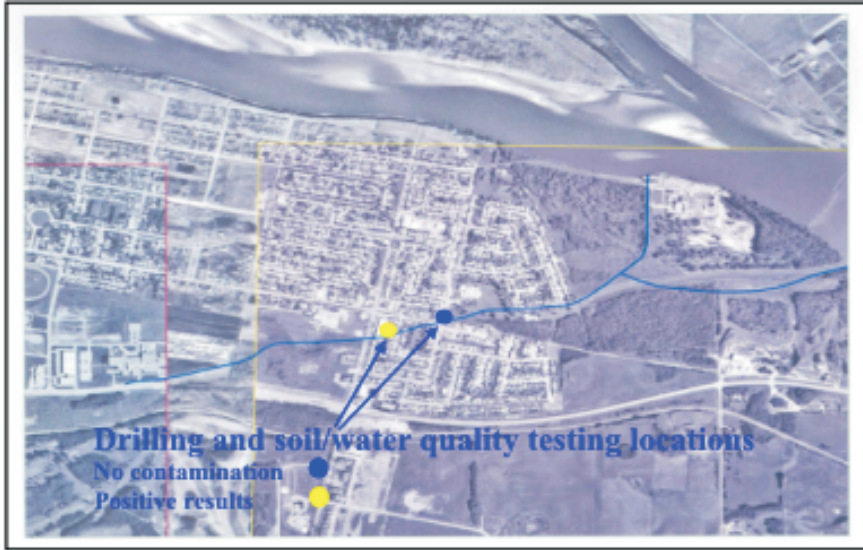
Figure 3. Established Testing Locations

Following the path of the old drainage channel to the east, additional testing was conducted. Two groups of test holes, including several near Berezowsky School, showed no evidence of any contamination. However, a single test in the alley between McRaney Crescent and 15th Avenue showed some mild contamination at a depth of 17 feet. Although the creosote levels were low and pose no risk to residents, the positive result was unexpected. Further investigations will confirm the extent of impact.

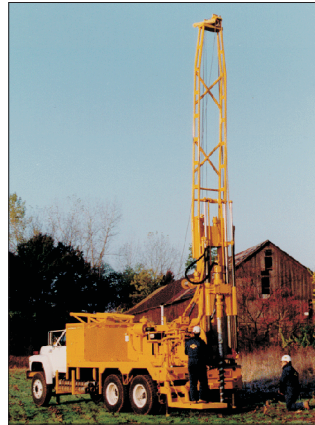
The wells are established using a 30-foot tall drill rig, mounted on a three-ton truck. An auger bit will remove the soil, and samples will be collected at various depths for analysis. Once the drill reaches the required depth, at least 17 feet, the auger will be removed and the hole will be backfilled with clay. Groundwater monitoring wells, a 6 mm (2.5 inch) PVC pipe with a screen, may be installed in some locations. The top of this well will have a permanent, secure cap that will be flush with or just below the ground's surface. Water samples from these wells will provide valuable information, now and in the future.

Figure 4. Example of Truck-mounted Drill Rig
